Hardware upgrades and validation of the Yebes DBBC (I)

J. González, P. de Vicente, C. Almendros

Informe Técnico IT-CDT/OAN 2013-14

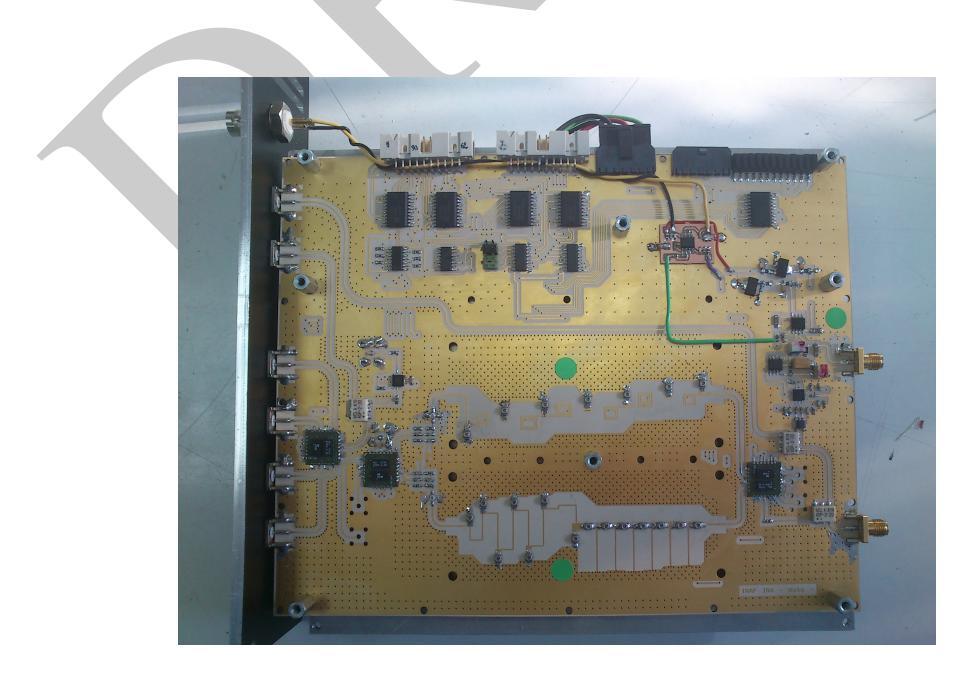
The modification consisted on obtaining a buffered copy of the analog signal produced by the integrated circuit and sending it to a BNC connector on the external plate of each CoMo. The reason for using a buffered signal is to prevent that an external short in the cables could stop the total power monitoring. M. Wunderlich designed a small PCB board which implemented this buffered output. The PCB is glued to the main board and connected with some cables to the board and to the external BNC connector.

Figure 3: Modified Unica 2 board in the CoMo to obtain a buffered copy of the analog signal from the total power detection

Fig. 3 is a picture of the modifed board. The PCB was attached to the main board using two sided tape.

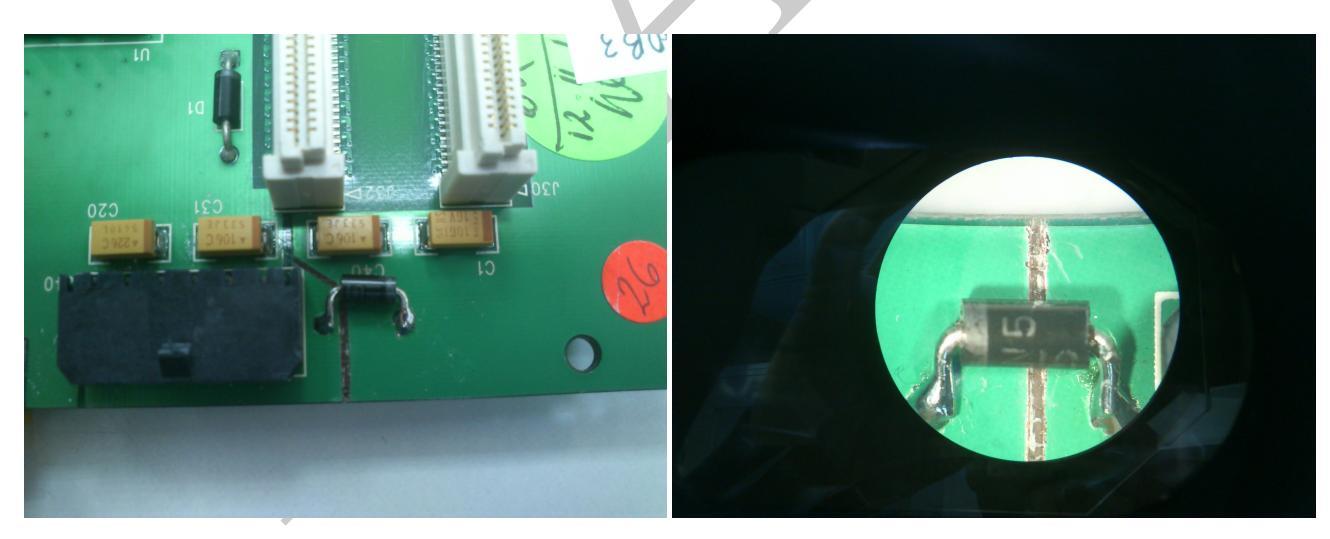
It was discovered that a difference between power levels in the ADB and CORE boards caused an increase of the system noise. This is described by M.Wunderlich in [2]. By correcting this effect, the noise is reduced and the range of input power levels at which the system works better is larger. Before the modification the power level at which the system works best (high SNR and linearity) was close to 38000 counts. It is expected that with this modification the range of input power values will be wider.

Figure 4: Milled channel and diode connecting both areas in the ADB1.

The modification consisted on reducing the supply voltage of the digital electronics by 0.5 V. This is achieved inserting a Schottky diode (1N5819) in the power plane. A part of the plane has to be removed to ensure that the only connection between both areas is done via the diode. The two areas are created by milling away the first layer of the multilayer board. At Yebes this was done with a cutter. Fig. 4 shows the milling and the diode connecting both areas.

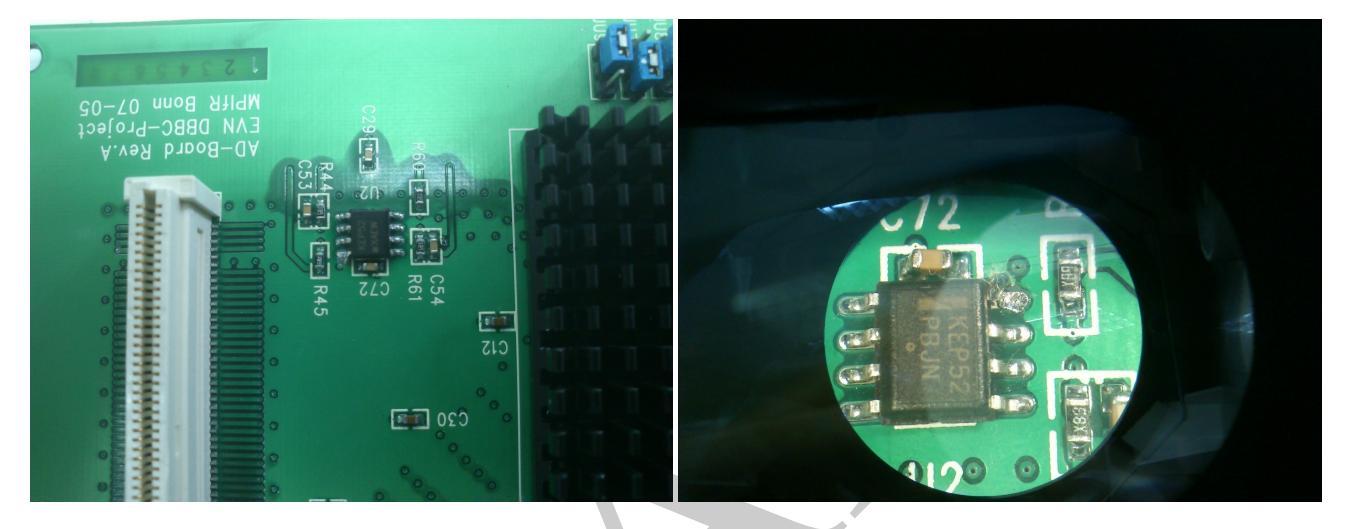
Figure 5: Clock driver circuit in which one its legs has been unsoldered and soldered in a different position.

The second required modification consisted on modifying the location of one of the legs of the clock driver circuit. The leg was soldered on a different pad so that the circuit uses a different supply voltage. Fig. 5 shows a picture of the modification in one of the ADB1s.

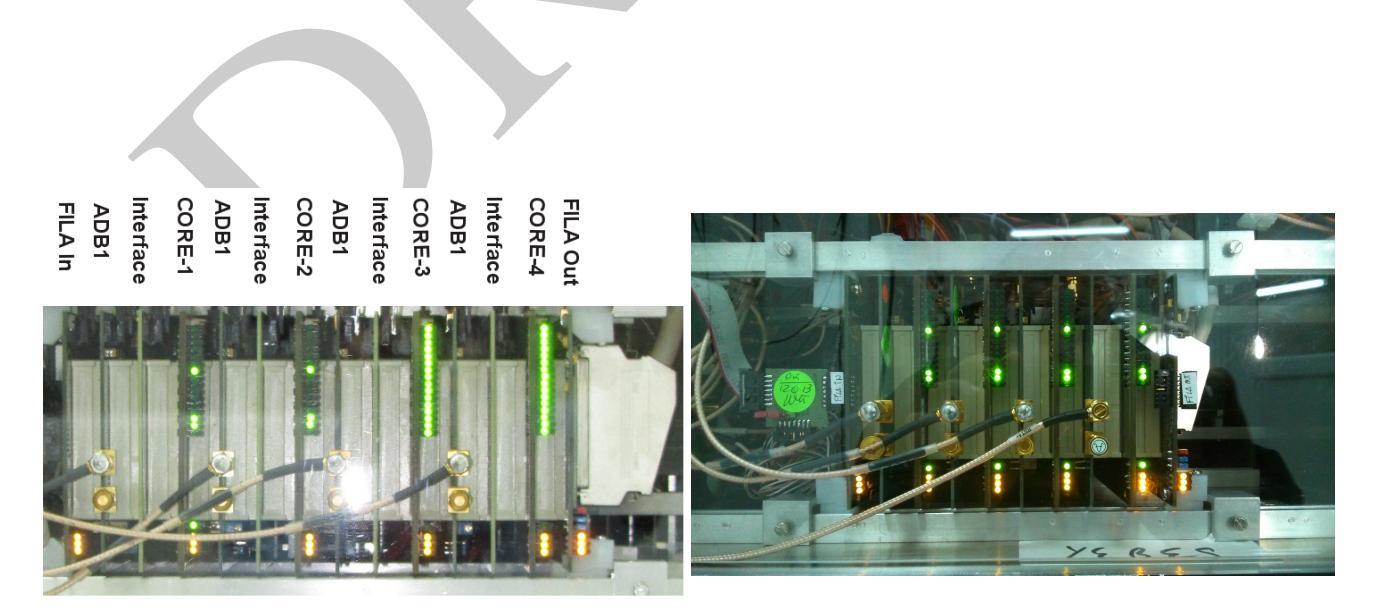
Figure 6: View of the old (left panel) and new (right panel) bus in the DBBC.

With these modifications, the interface boards that connected the CORE with the ADB must be removed. Some power supply cables can be taken away to unclutter the space. Fig. 6 shows a picture of the BUS before and after the modification. The interface boards have disappeared in the newer picture.

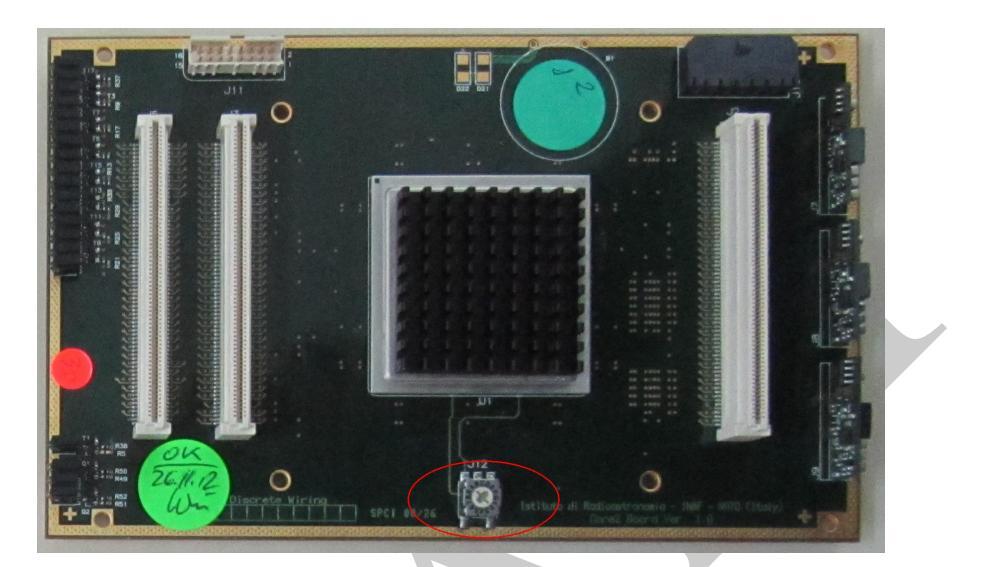
Since the DBBC did not work correctly the DBCC was sent for inspection and repair to Bonn where it was found that synchronization problems involving last Core2 modules could be due to swapped addresses on the two boards (the reader can find a picture of the switch that gives address to a board in figure 7). In addition to properly adjust the addressing switch several tasks were performed in MPIfR (Bonn).

Figure 7: Core2 top view. This side faces the output of the stack. The address switch has been red circled.

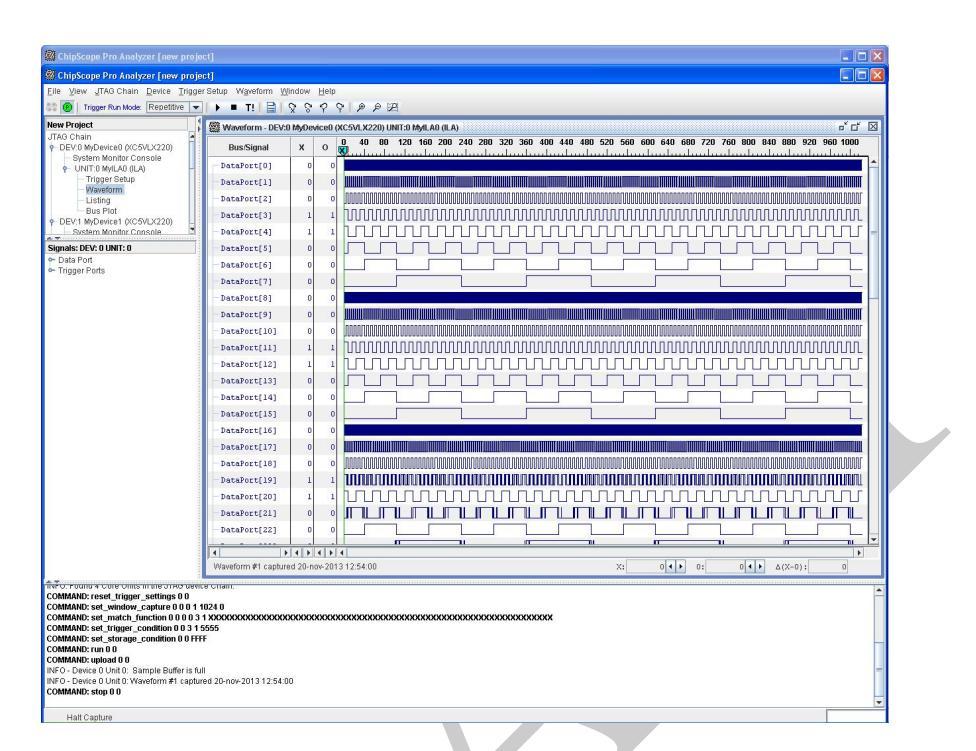
lines (total of 8 counters). To diagnose the digital electronics performance, a software digital oscilloscope, aka Chipscope, is available at the DBBC embedded PC. Once the application is started, once should click on open cable/search JTAG chain to discover all the programmable devices under an specific USB port. Previously we selected the USB port we wanted to explore. Figure 10 shows an example of the four-cores DBBC digital stack detected by Chipscope at Yebes. Clicking the trigger button captures and displays one second of data flowing across the stack, which in this case must show the counter pattern. We found that in Yebes only two counters were successfully implemented within the first 16 lines of each Core2, while the remaining 48 lines contained noisy bits over the counter pattern (figure 11). Apparently this error was due to a mismatch between software versions and should not be considered relevant. LEDs 13 and 16 were not blinking synchronized.

Since LEDs 13 and 16 were not blinking synchronized, the DBBC was opened in a bench and inspected for loose connections. We found that a cable tie was stretching the flat cable used by the programmer, so the JTAG connector was not properly inserted. Removing the cable tie and resitting the JTAG apparently solved the synchronization problem.

Figure 11: This screen capture shows two correct binary counters in the first 16 lines and another one wrong for the following 8 lines. Device 0 refers to the first core in the stack (IF A)

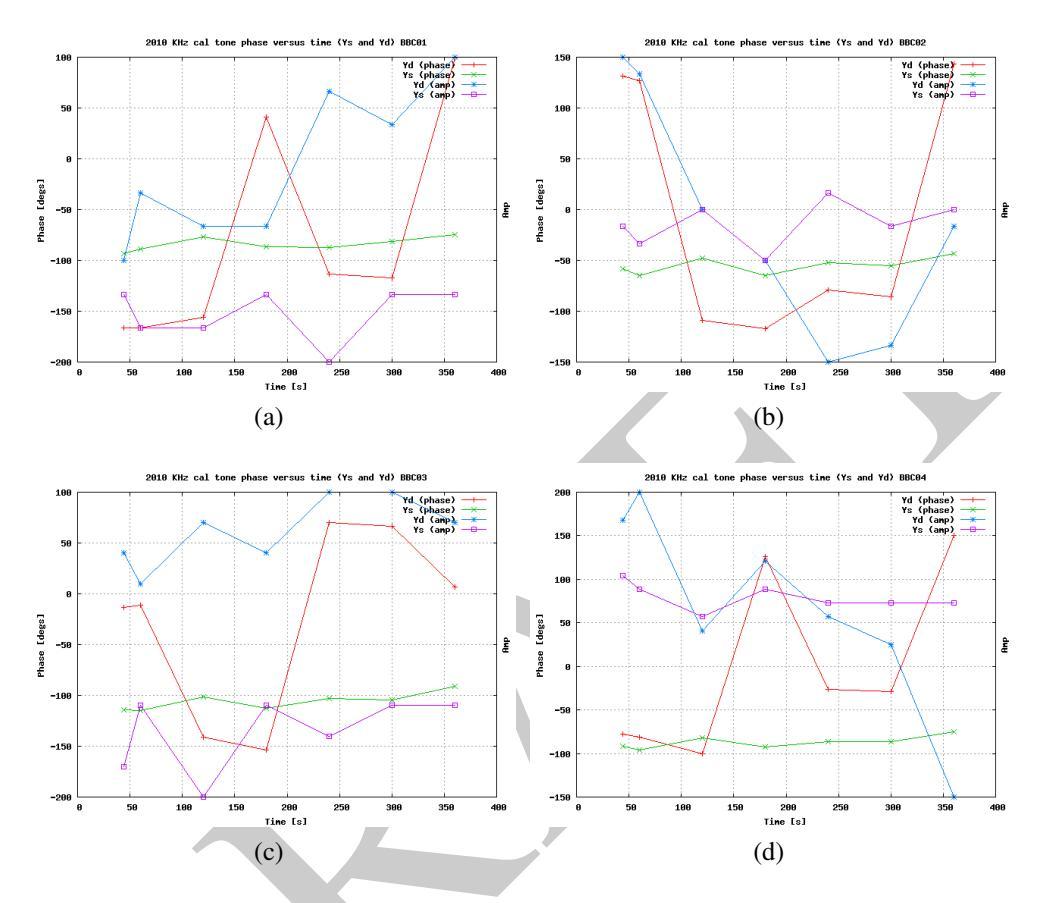
In the 7 samples, 1 second of data recorded, and approximately 1 minute apart, time series for 16 bbcs and 2010 KHz tone, a phase instability can be easily appreciable for the digital backends, while the vlba5 terminal recordings does not change more than a few degrees. The first four channels are shown in figure 17 as example, while the same erroneous pattern was found for all bbc. Being this an important issue that can have impact on correlation, further tests were carried on to find out if the DBBC is modifying the phase of the signal.

Figure 17: 2010 KHz pcal tone amplitude & phase for the first four channels within a r4616's scan. Extracted with bpcal

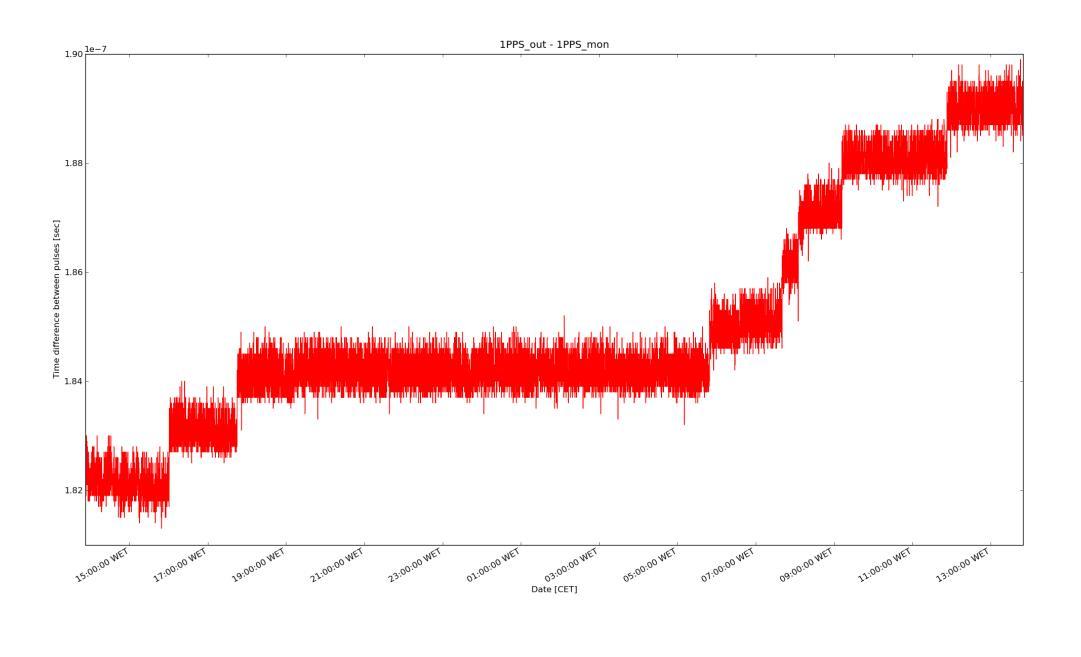
The difference between pulses was increasing in a non-linear trend, which could be due to a mismatch in oscillation frequency. The evolution of the delay consists on discrete jumps that follows no clear pattern in time or amplitude but always in the positive direction following a sort of quadratic curve. With the experience that bad connexions usually results in synchronization

Figure 21: 1pps difference

problems (section 4.2), it was decided to disassembly the electronics, clean all the connectors with pressurized air and reassembly the system, with special care of not remaining any loose connection. After this operation the quadratic trend disappeared but 1 nsec jumps were still visible from time to time (figure 21).

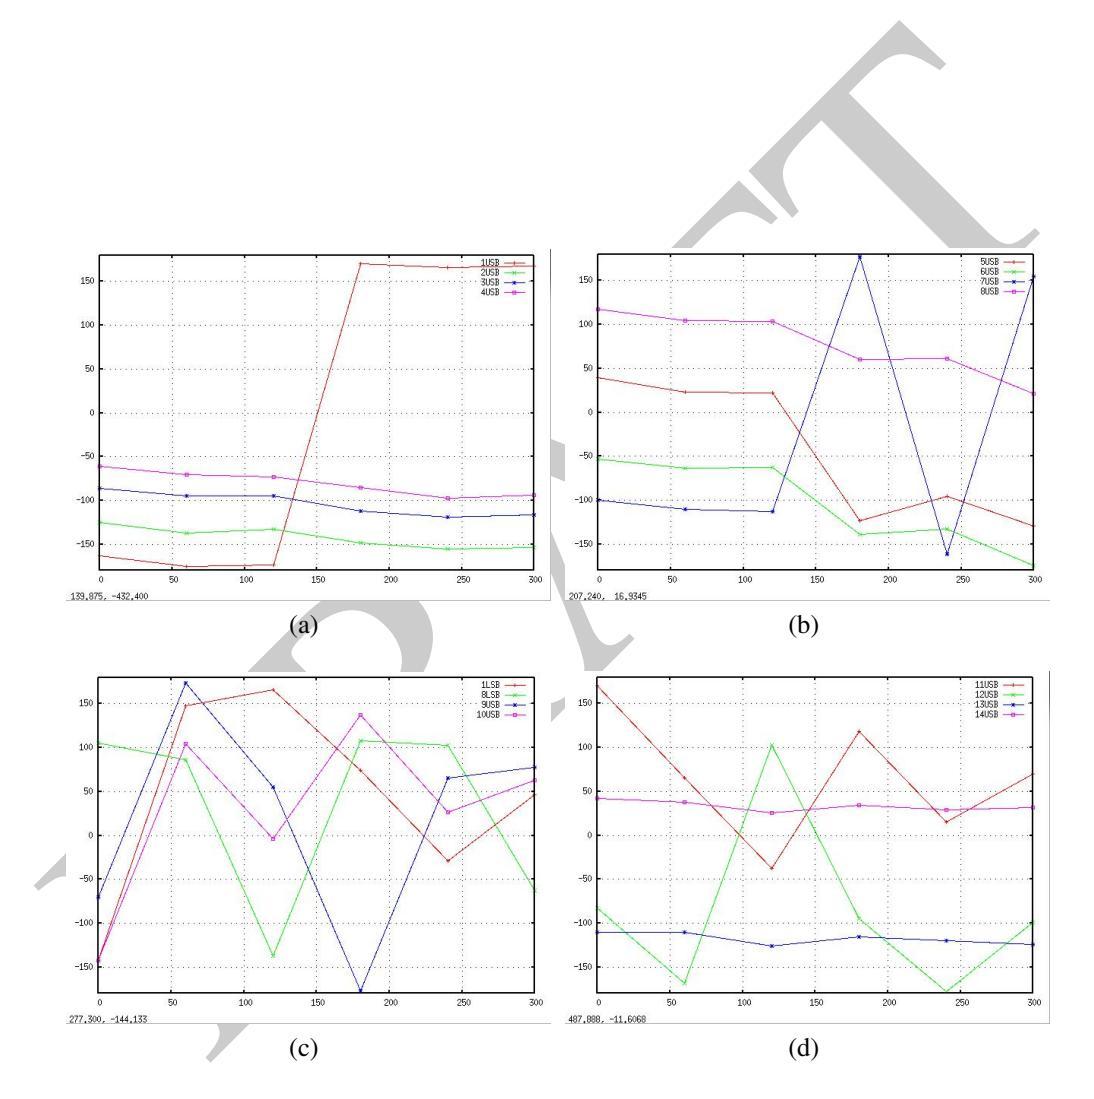
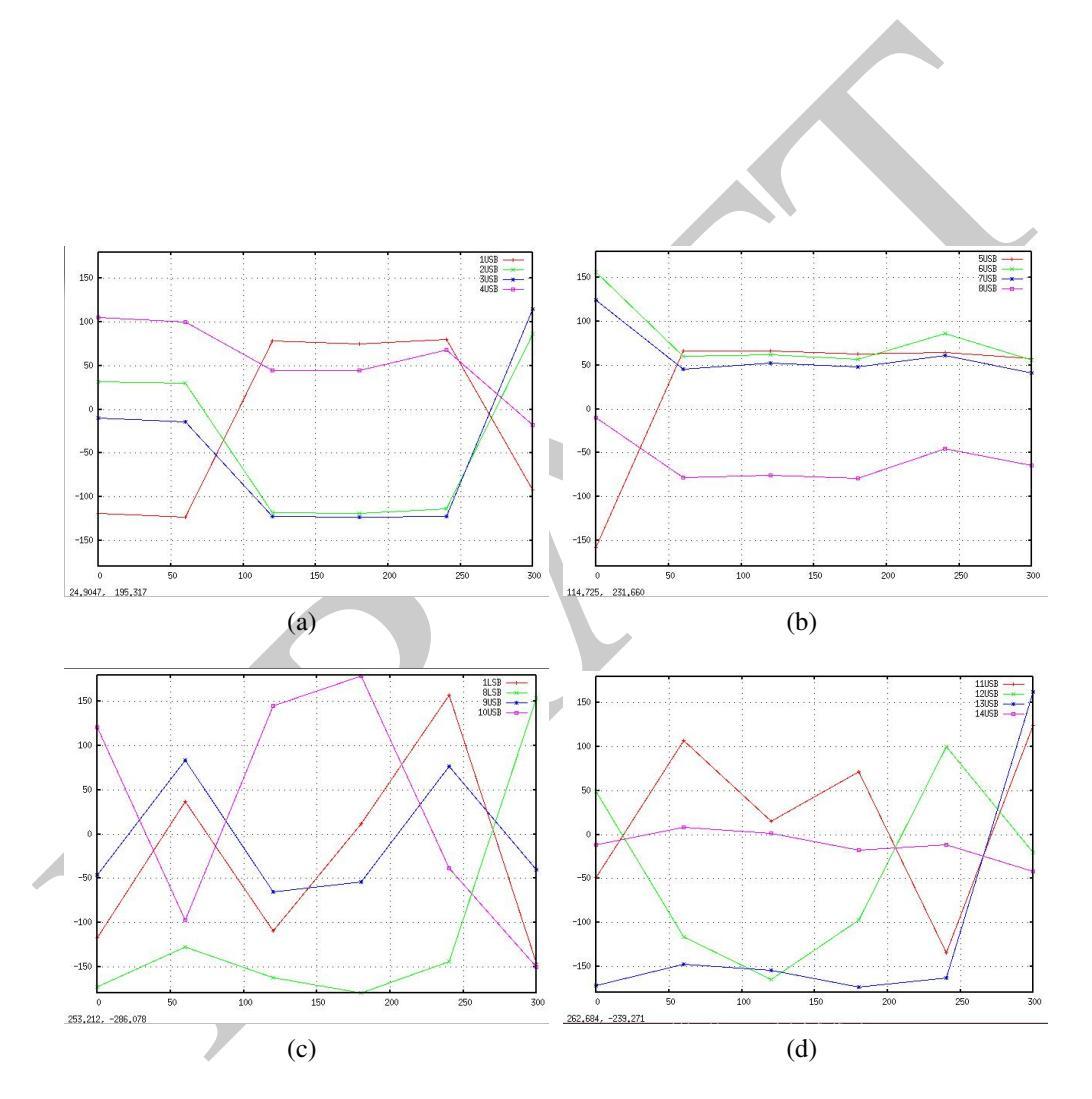
To check the repercussion of last action in the phase stability of the pcal tones the test in previous section was repeated. Phase instability seemed to be solved when the first test was run, but when the test was performed a day later the jumps appeared again (figure 23 and figure 24).

With plots in figure 26, figure 23, figure 24, and the 1pps difference evolution for that time interval (figure 27) one can suspect that the jumps in the 1pps at VSI could be introducing instability in the phase of the pcal tones.

Figure 23: bpcal phase extractions for tone at 2010 KHz. Data recorded at 12:00:00 on 28/01/2014.

Figure 24: bpcal phase extractions for tone at 2010 KHz. Data recorded at 12:20:00 on 28/01/2014.

A wrench was used to tighten the connectors on hot trying to force jumps in the delay. To access the SMA connector that carries the clock signal in the ADB3 it is needed to bend the power supply cables for that same board. Just in that moment a new jump appeared at the oscilloscope. As other stations has reported problems with the cables, Yebes asked for another set of power cables to replace actual ones.

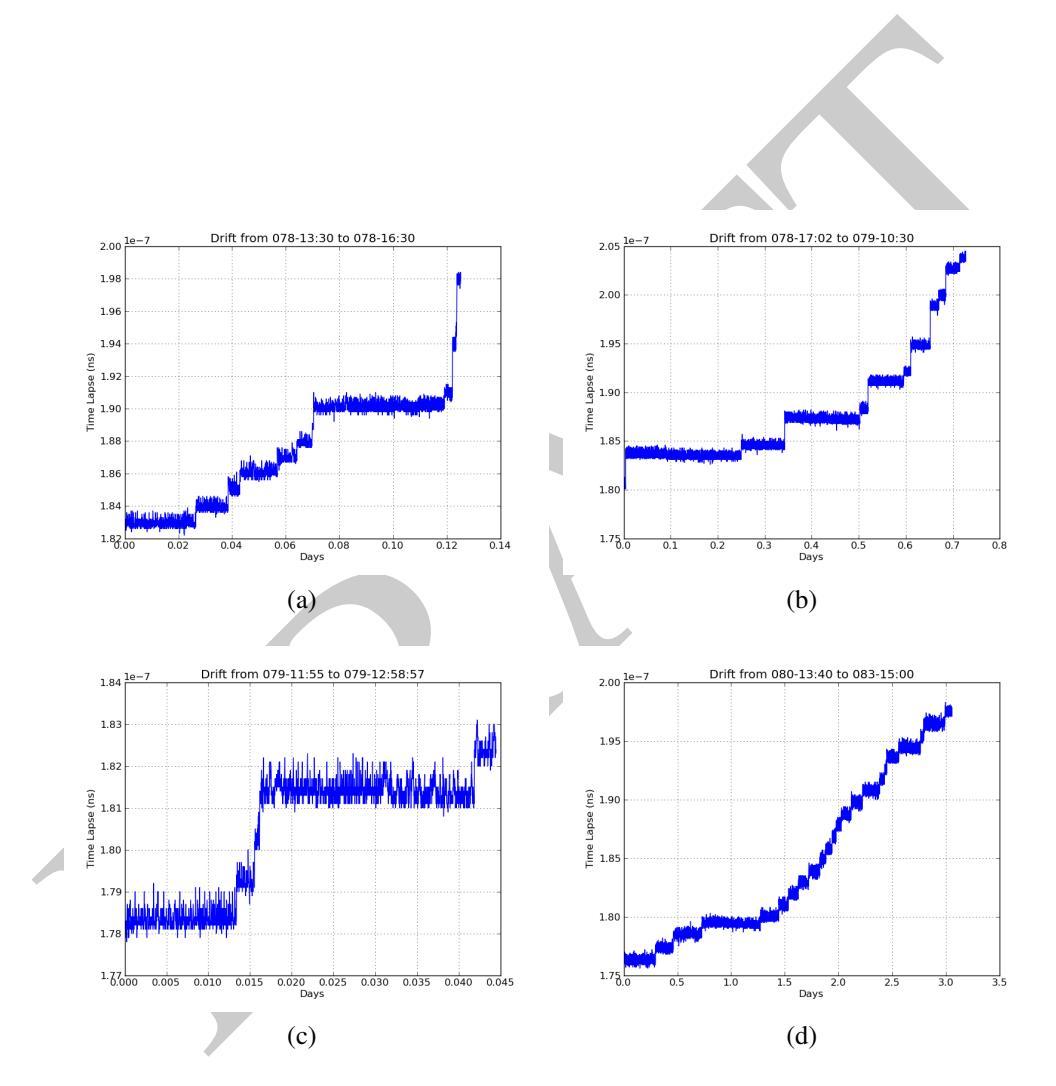
Once the cable replacement set arrived at Yebes, several tests done by P. de Vicente and A. Pérez using the new cables and swapping boards didn't solve the drift, raising the suspicious of a fundamental error in the system design. Some of the plots from these experiments are attached below.

Figure 26: Several tests showing 1 pps drift. a) Swaped boards ADB1#3 and ADB1#4. b) CLK cable to ADB1#3 replaced by shorter one. c) ADB1#3 switched off. d) ADB1#3 and ADB1#4 switched off.

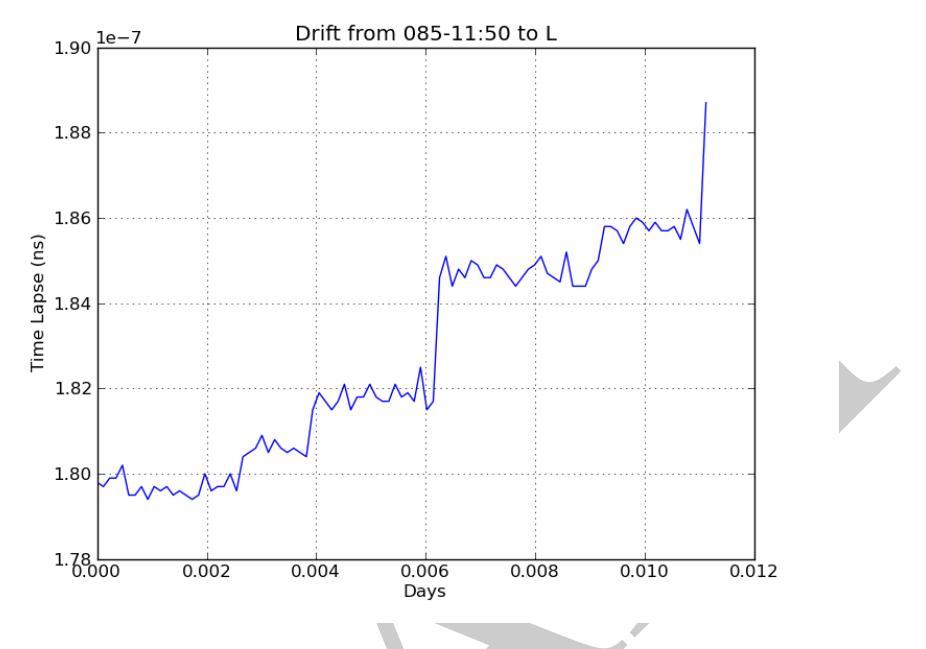
Figure 27: 1pps drift with a new ADB1#3 board.

Finally in May 2014 the DBBC was sent back to MPIfR in Bonn for a final inspection. It was discovered that the power level from the power supplies at the last boards of the bus was marginal, furthermore below the nominal values. The voltage was adjusted and other minor modifications were performed like replacing the radiators at the COREs by narrower ones to avoid its proximity to the next ADB. After these modifications phase jumps disapperared, no 1 PPS drift was observed for days and stable fringes were found in X, Xband extended and S band for experiment R16xx.
