Hardware upgrades and validation of the Yebes DBBC (I)

J. González, P. de Vicente, C. Almendros

Informe Técnico IT-CDT/OAN 2013-14

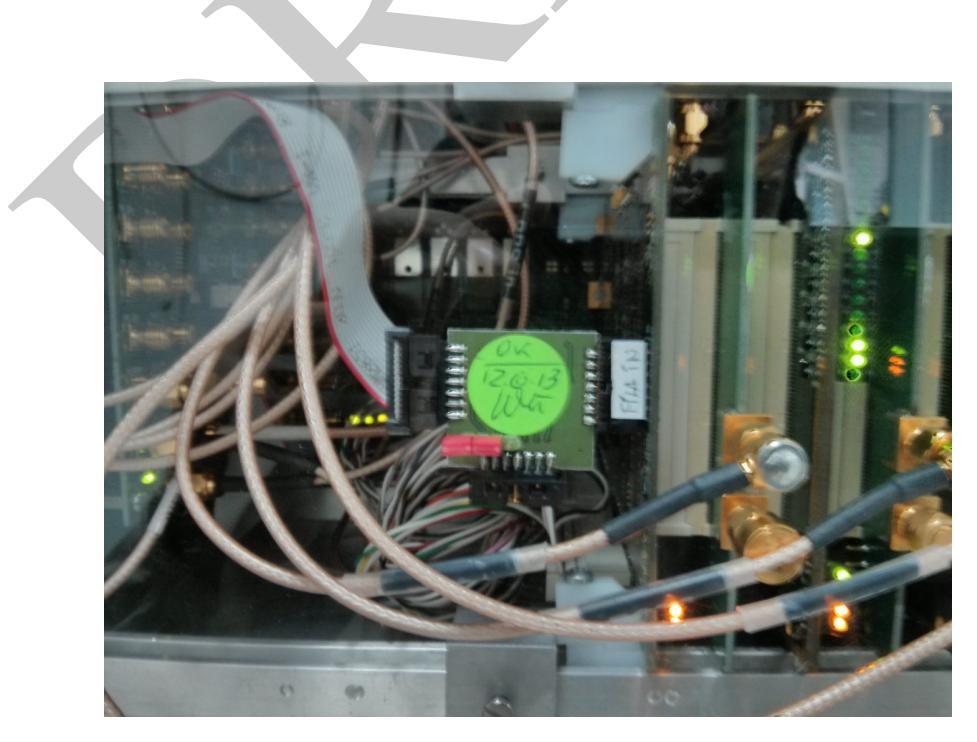
To prevent transport damages, the digital electronics stack was partly dismantled, and the system was reassembled in Yebes. Once assembled $(FiLa + ADB1_1 + Core2_1 + ADB1_2 + Core2_2 + ADB1_3 + Core2_3 + ADB1_4 + Core2_4 + FiLa)$ a JTAG booster was needed at the beginning of the stack as shown in figure 8. This small PCB has two functions; it acts as a demultiplexer in case there is a FiLa10G embedded into the system so it can be programmed through just one USB port (this is not the case in Yebes), but it is also an amplifier for programming currents to the FPGAs since it was seen that in some cases the last boards in the stack did not receive enough power.

Figure 8: View of the JTAG booster through plexiglas during normal operation

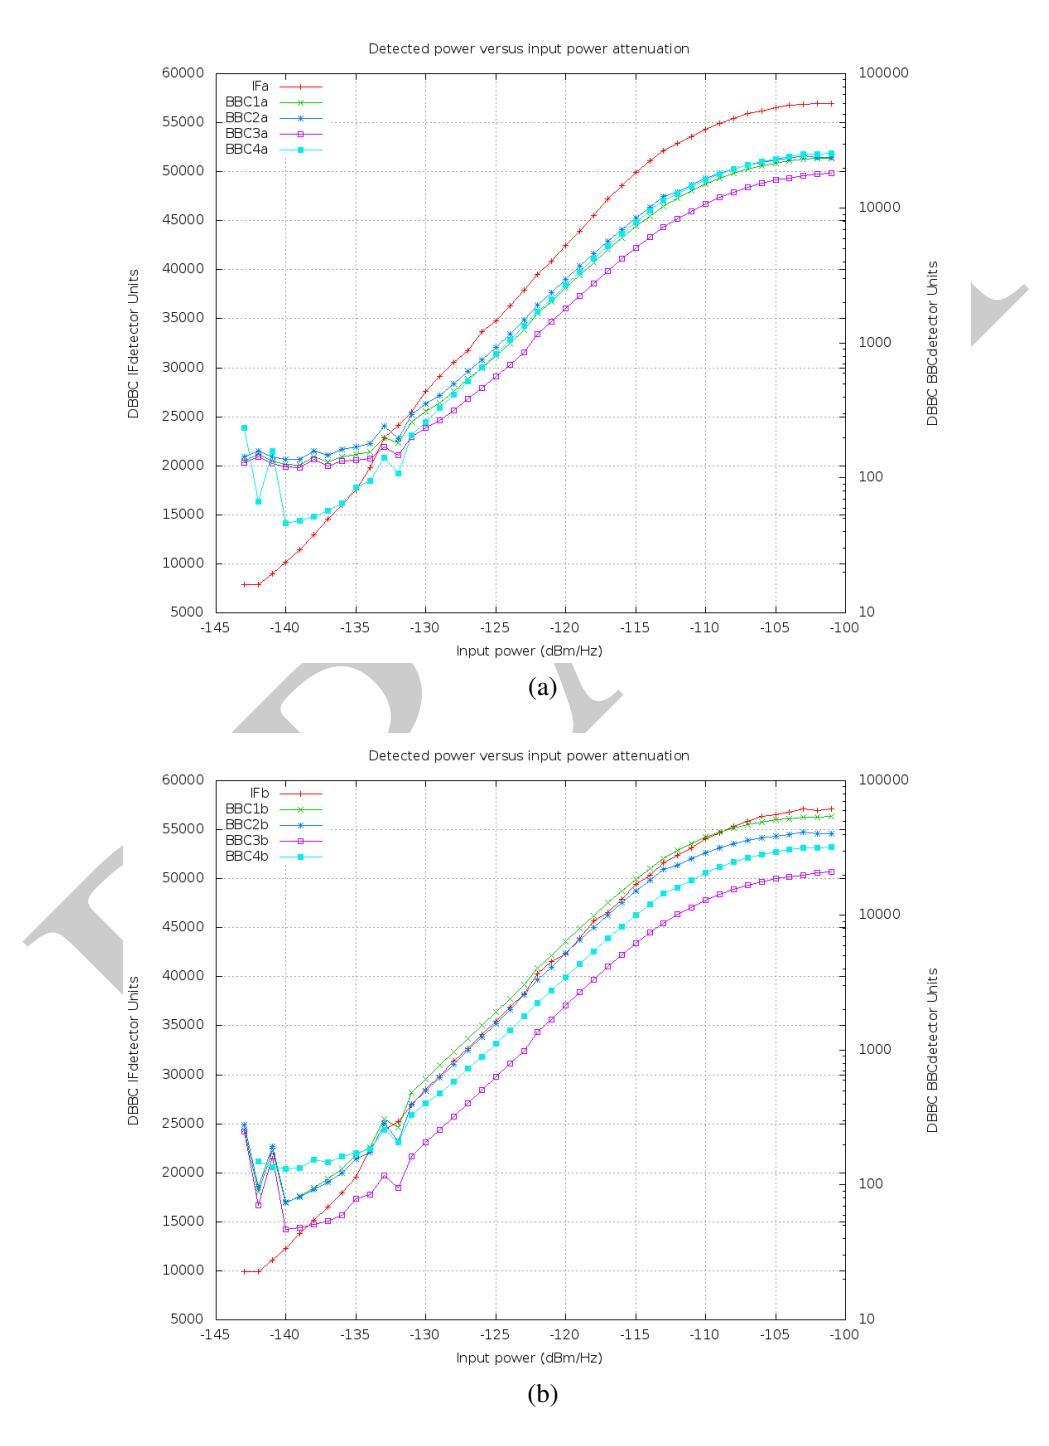
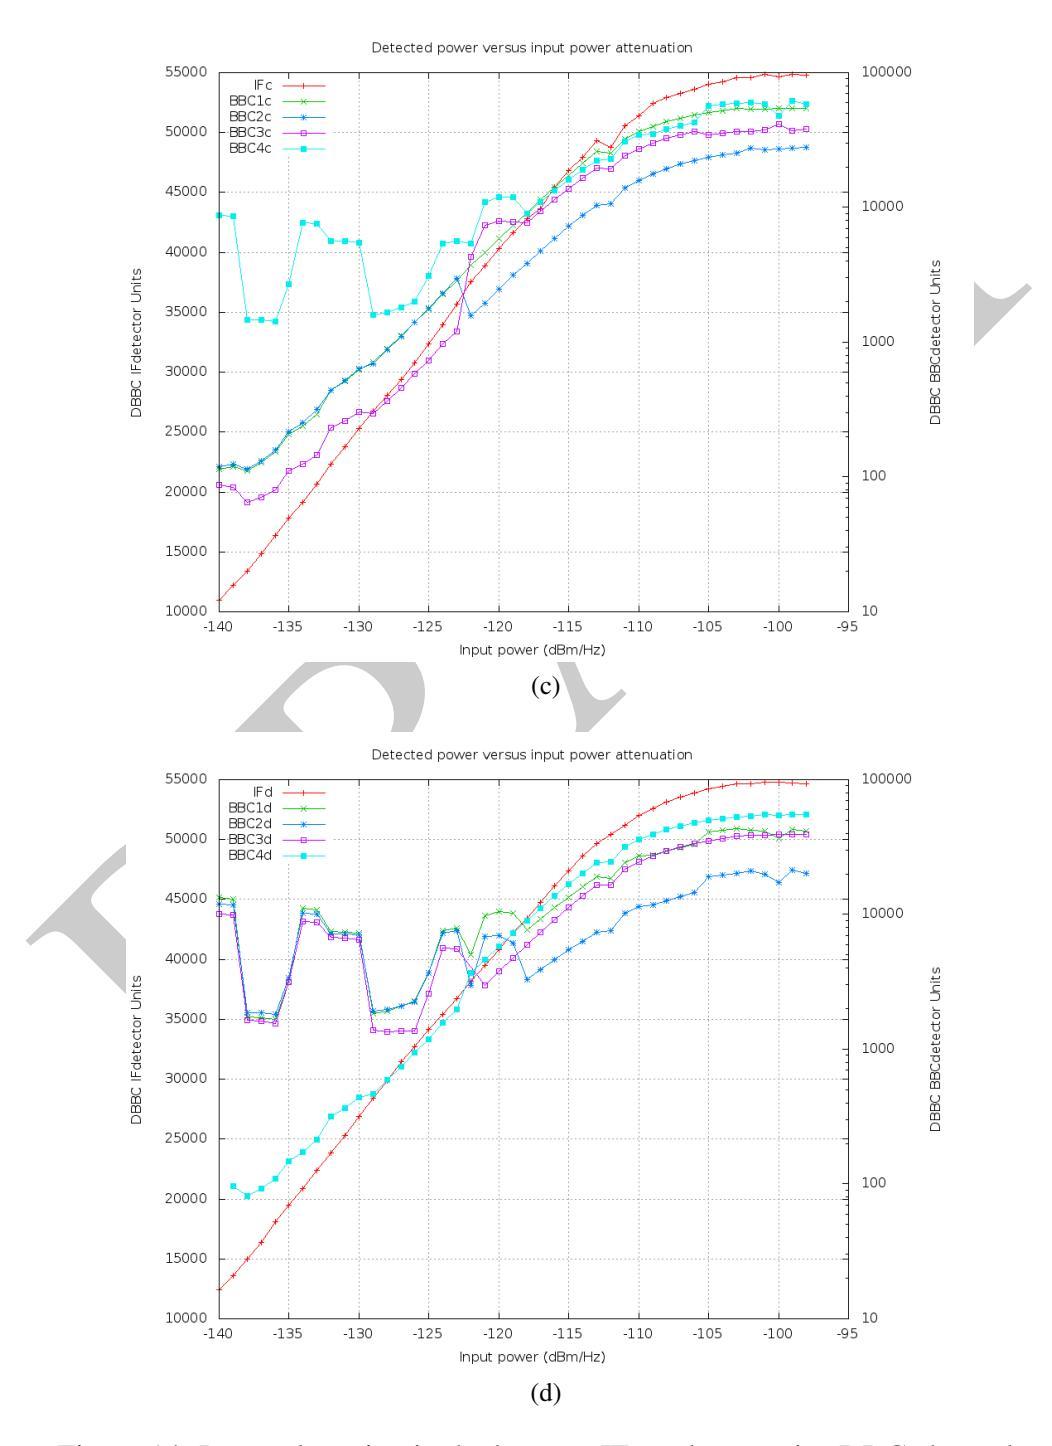
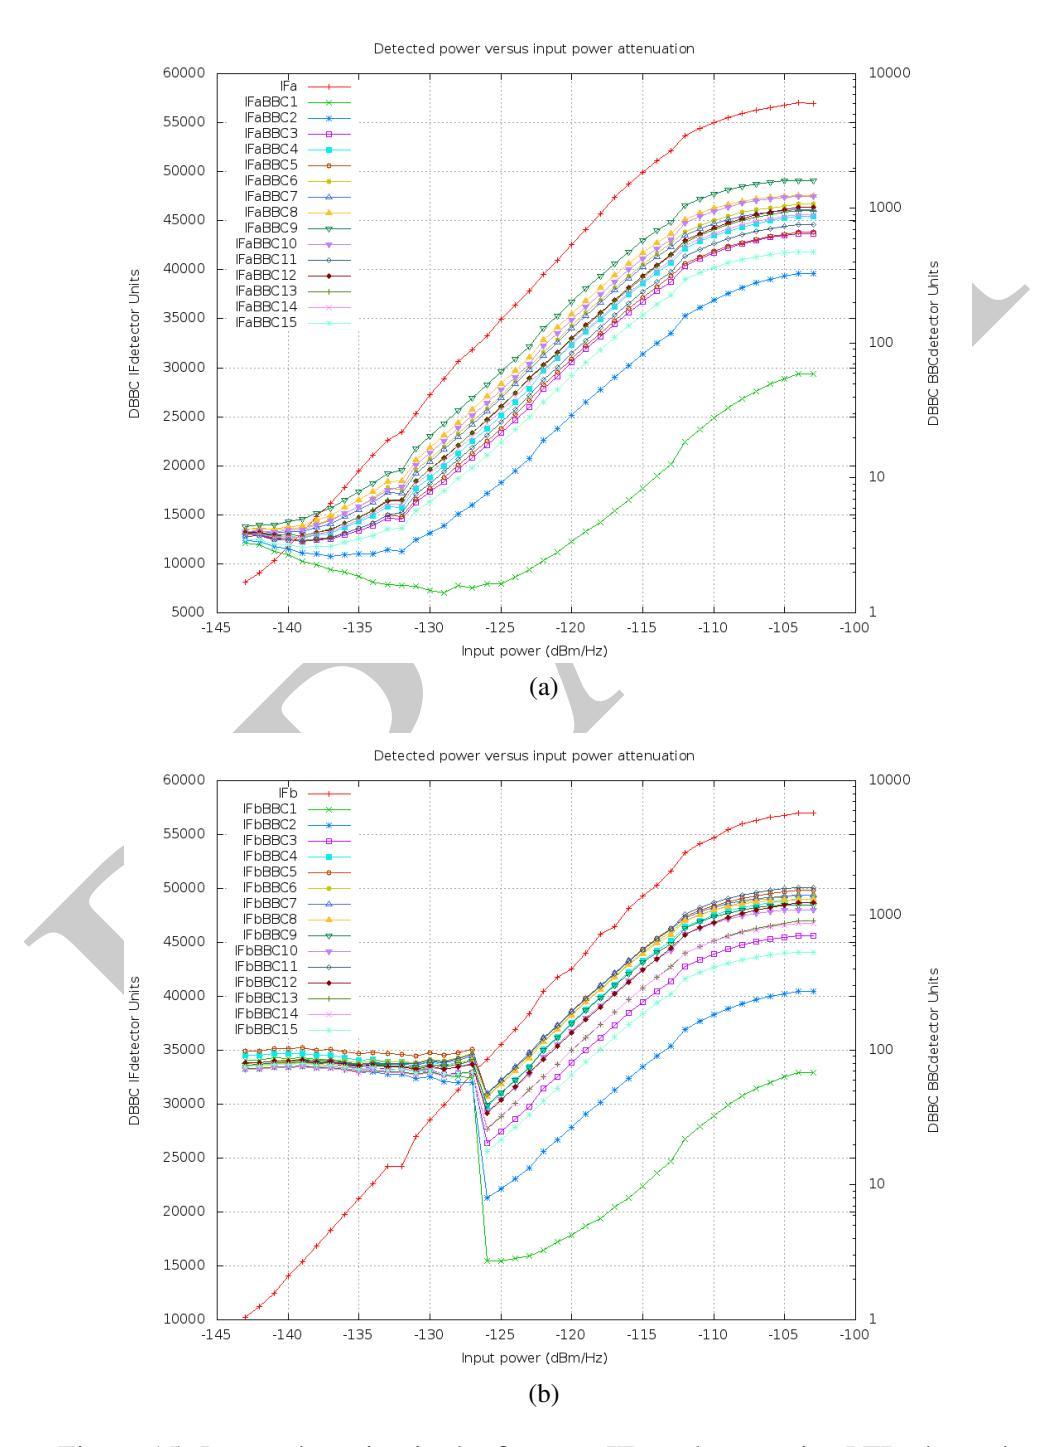
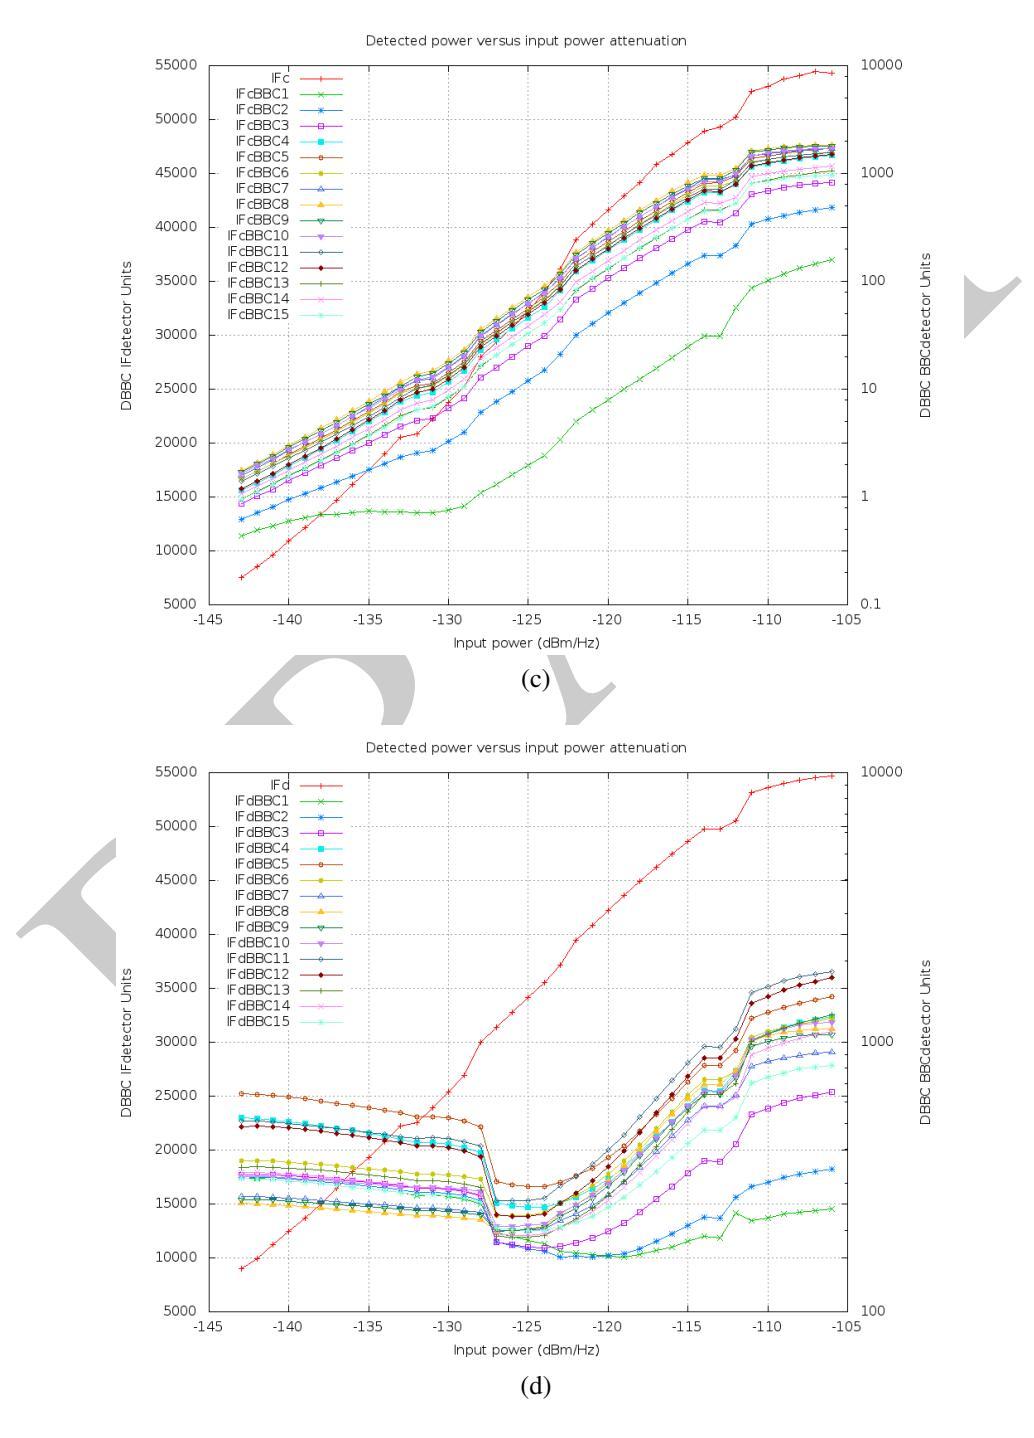
Relative to data in figure 15 from the DDC observing mode, the total IF power detection has not experimented any relevant improvement (as expected), but still has a large dynamic range that reaches saturation at about 50000 counts (30 dB of dynamic range), but surplisingly the SNR does not seem to have improved in any base band detector, moreover it is worse now for IFC and IFD than it was before the hardware modifications. Total IF power has to increase now over 43000 to allow BBCs to behave in a linear way while according to the results in [6] this threshold stood at 35000 before the updates. This experiment must be repeated to check repeatability of results, including the exchange of core2 position in the stack to discard position-dependency before investigating a problem of sensitivity in some of the cores.

In the other hand, these measurements show a little improvement when observing through PFB configuration with respect to the last test. Core2-A and Core2-C behave linearly from $\simeq 23000$ to more than 50000, and for all channels. Core2-C has experimented a significant improvement since data from February were completely erratic. Core2-B and Core2-D have less linear range although still enough, starting at approximately 35000 IF counts until above 50000. There is a special issue involving Core2-D data. The first narrow bandwidth channels have different slopes. This maybe related with lack of power, as we have seen that the first channels in every Core-2 show less power than the rest. In any case special attention should be paid in the future to this Core-2 when running in PFB mode.

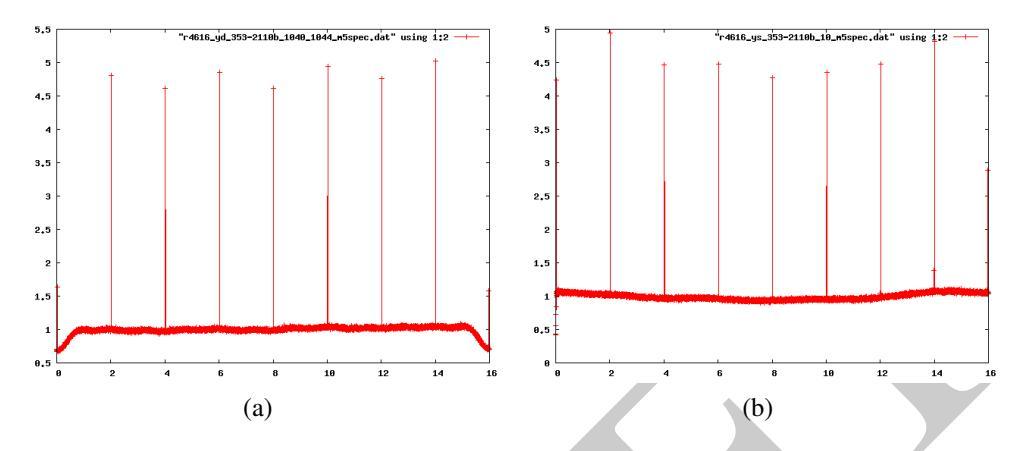
To understand what all the parameters and options mean just run m5spec with no arguments. Results are shown in figure 16, where a good SNR can be seen for both recordings. One strange behaviour that can be detected at a glance is that the base band channel spectrum in the vlba5 terminal does not roll off at the end of the band although it is expected that the base band filter drops the power 3 dB at 7.4 MHz. However, any wrong behaviour is detected for the dbbc spectrum at least for the first channel.

Figure 16: mk5spectra spectrum 4 seconds data recorded at 21:10:40 (bbc overlapped), scan r4616_ys_3532110b. a) DBBC, b) VLBA5

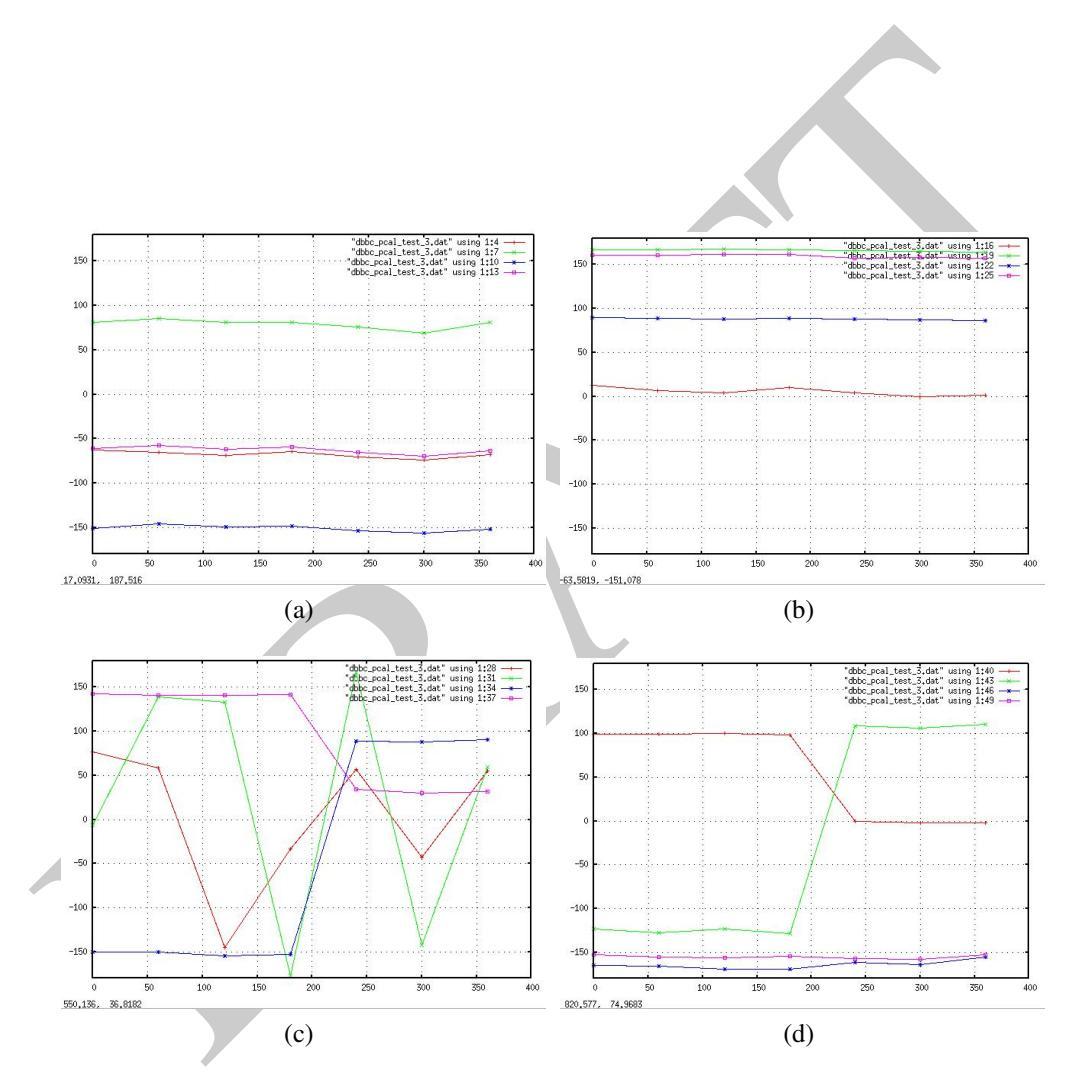
Using the same setup as in r4616, pcal tones phase show stability for these minutes-scale tests in every Core2 except that corresponding to IFC (copy of S band), where tens of degree jumps can be easily detected (Figure 19c and 19d). To help with the interpretation of data a table showing the channel mapping for a typical geodesy experiment is included in the appendices section. Inside the DBBC each IF goes into an specific Core2, which can implement up to 4 bbc. Therefore, channels 1 to 4 belong to the first Core2, 5 to 8 to the second and so on. The last two channels from the last Core2 are not usually included in the observation. Notice that data from channels 1LSB and 8LSB are not valid since there is no tone at 2010 KHz for those channels (lower bands has pcal tones at 990 + n * 1000 KHz)

Figure 19: bpcal phase extractions for tone at 2010 KHz using the same configuration in r4616 a) 1USB, 2USB, 3USB, 4USB, b) 5USB, 6USB, 7USB, 8USB, c) 1LSB, 8LSB, 9USB, 10USB, d) 11USB, 12USB, 13USB, 14USB

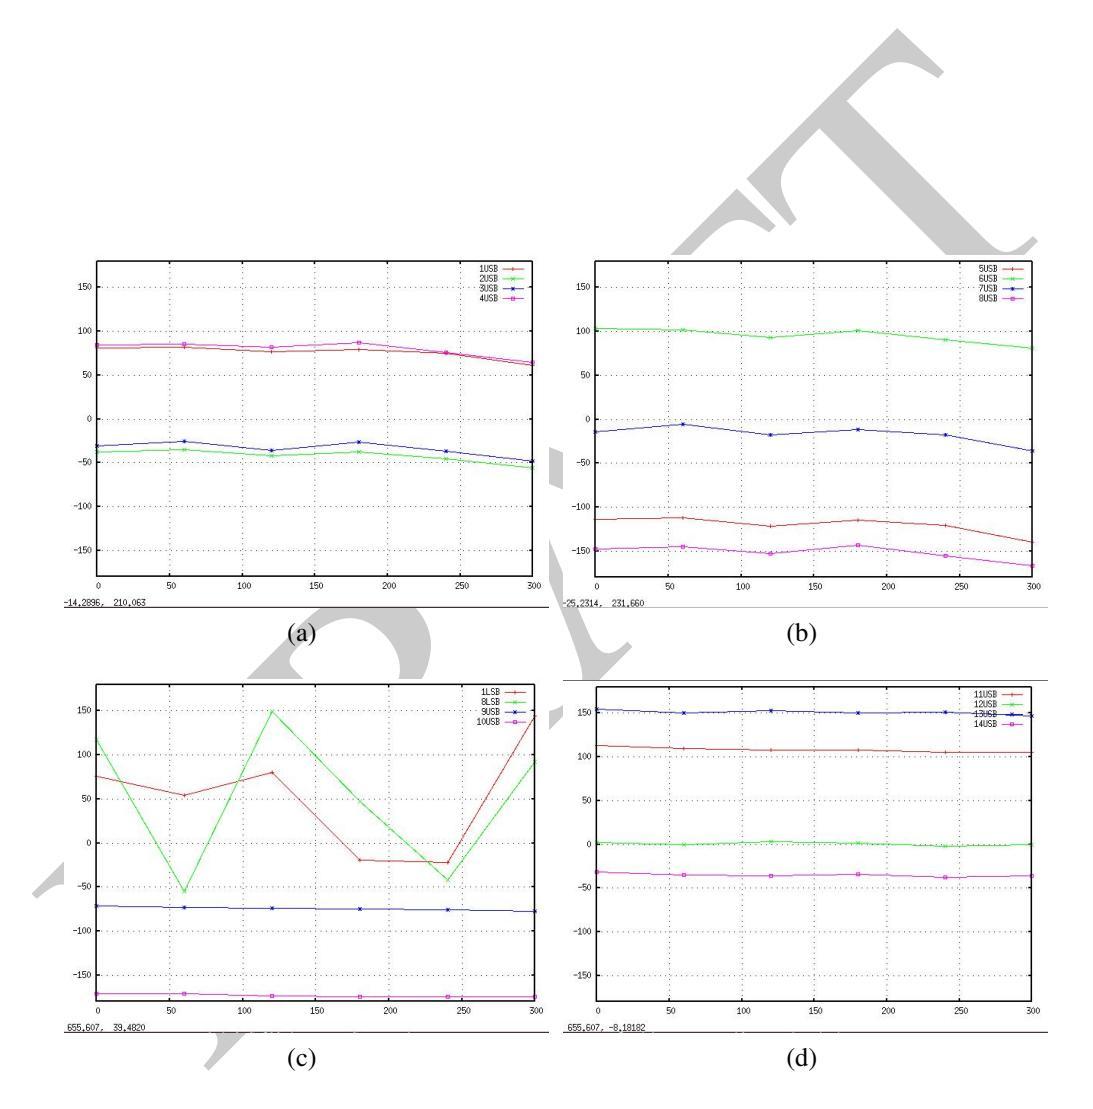
To check the repercussion of last action in the phase stability of the pcal tones the test in previous section was repeated. Phase instability seemed to be solved when the first test was run, but when the test was performed a day later the jumps appeared again (figure 23 and figure 24).

Figure 22: bpcal phase extractions for tone at 2010 KHz. Data recorded at 12:00:00 on 27/01/2014.

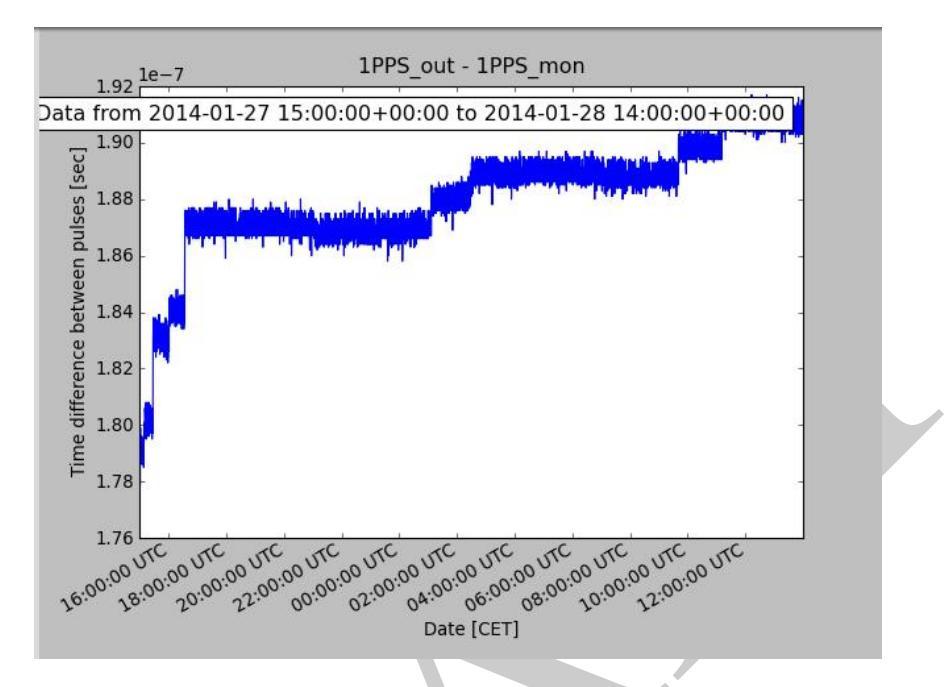
With plots in figure 26, figure 23, figure 24, and the 1pps difference evolution for that time interval (figure 27) one can suspect that the jumps in the 1pps at VSI could be introducing instability in the phase of the pcal tones.

Figure 25: 1pps difference while experiment above

A wrench was used to tighten the connectors on hot trying to force jumps in the delay. To access the SMA connector that carries the clock signal in the ADB3 it is needed to bend the power supply cables for that same board. Just in that moment a new jump appeared at the oscilloscope. As other stations has reported problems with the cables, Yebes asked for another set of power cables to replace actual ones.
